Volunteer Restoration News

Battleship Texas BB35

VOLUME 1, ISSUE 1

JUNE 1ST, 2007

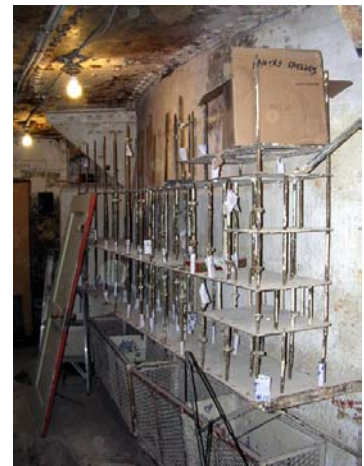
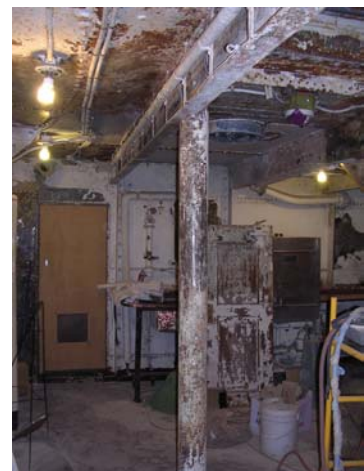
Just to refresh everyone's memory the two photos on the right are what the Pantry looked like in April 2006.

The Rust Busting is "Done", the welding repairs are done, the following needs to be accomplished;

1. Polish the copper work tables and lacquer them –
2. Refrigerators – sand the compressor section of the starboard unit. Remove the paint from the interiors of both units (best method is still being worked out). Fabricate the metal shelves; Mark Gruver is currently working on this. Fabricate the Freezer parts, currently at the outside vendor, don't have a completion date for this but will soon. Fabrication of frig doors; will build a Styrofoam mock-up to determine correct dimensions before sending info to vendor for fabrication. Repair the metal legs that support the refrigerators.
3. Dish Rack – All the brass pieces for the rack were completed, next part is to sand the four 9 foot long shelves to a 220grit finish. We are not to prime per instructions of Rustoleum for the appliance epoxy enamel that will be applied.

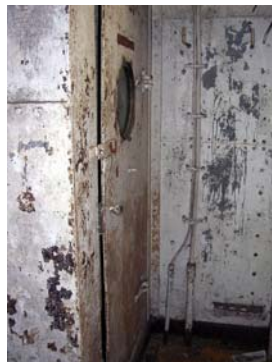
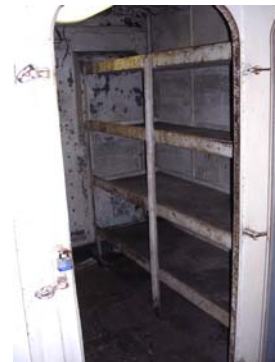
Repair Party Locker (main deck), David Glass has continued with the Rust Busting phase of this project and has started the overhead area.

This is the time consuming part of any project, still much to do.....
